## Halfway Pond

Some threats to the environment along the southern section of Mast Road and along other portions of the shore

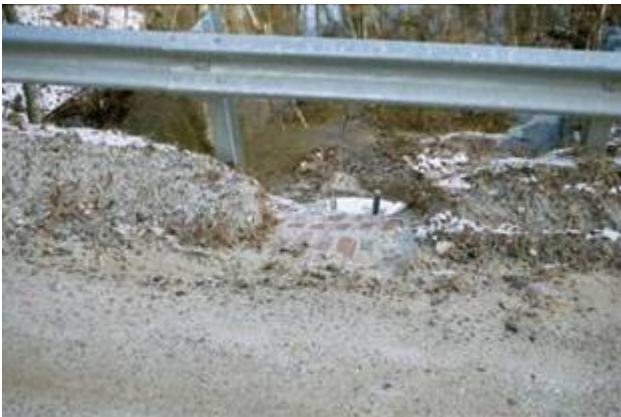
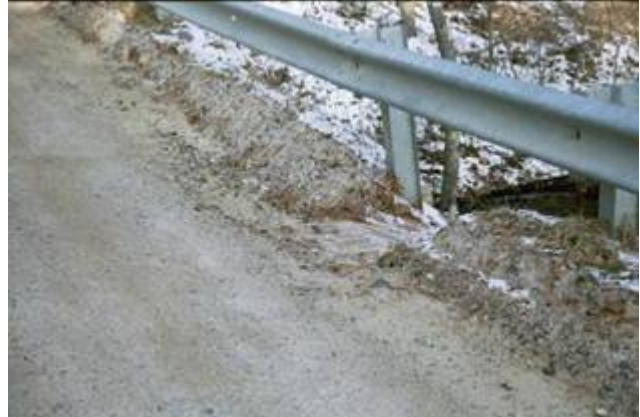
2. In the middle of the Mast Road bridge which crosses the Agawam River, the Highway Department has constructed a cut which feeds directly into the river. Whenever it rains, a large amount of water, sand and contaminated road runoff flows directly into the river, and silt now forms a bar halfway across the river. The runoff flows down to the bridge from both the north and the south.

The runoff from the south flows more than 2/10 mile from the east on Halfway Pond Road, turns onto Mast Road, and then flows more than 1/10th mile further on Mast Road. In other words, the Cape Cod berms of Halfway Pond Road and the earthen edges of Mast Rd. create a long sluiceway which feeds many gallons of contaminated water directly into the Agawam River.

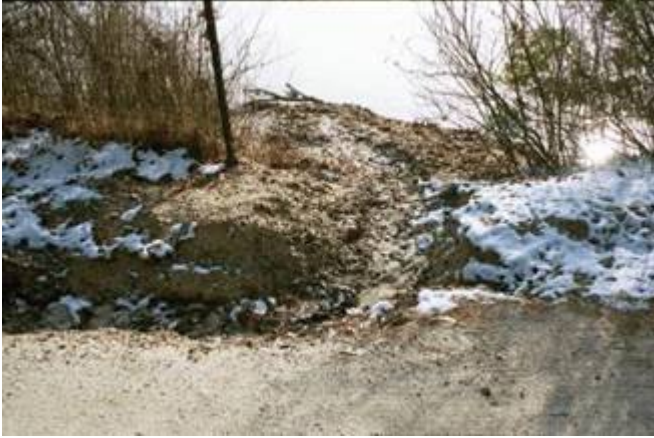
1. Several thousand feet of Mast Road lie just a couple of feet from the west and northwest shore of Halfway Pond. This is a one-lane section of dirt road around the pond. There are a number of places where boaters and fisherman have completely destroyed the very narrow vegetated buffer along the shore, and, in these places, road runoff flows directly into the pond from the dirt road. In addition, over the years, the Highway Department has made a number of narrow cuts in the narrow vegetated buffer

along the shore that allow road runoff to flow directly into the pond.

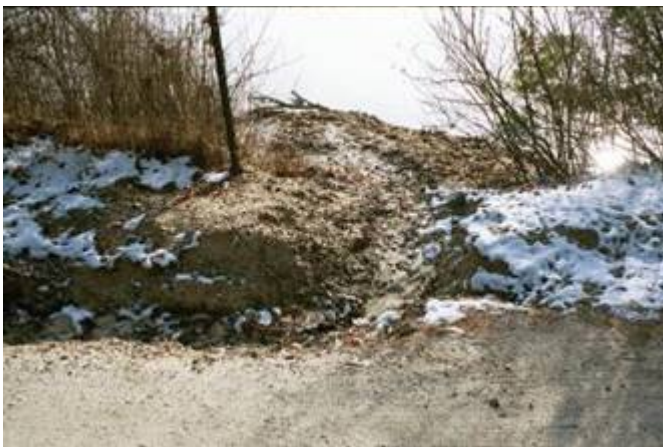
Recently, the Highway Department made at least six new cuts through this narrow buffer. There are no catchment basins along this section of road, and careful planning would be required to create ones which would not adversely affect this fragile area. In places, the cuts have eroded severely and carried a great deal of sand and silt into the pond.

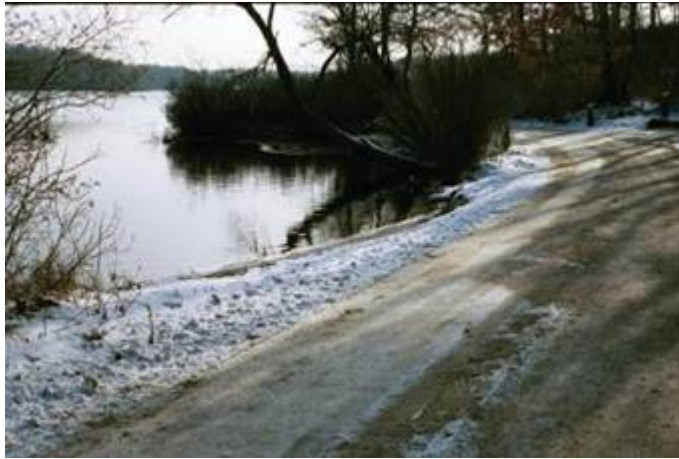
3. In addition to traffic coming up from Halfway Pond Road which continues north around Halfway Pond along the shore, there is the traffic which comes onto Mast Road from Agawam Road and Fawn Pond Road. A surprising amount of this also turns north and takes the very fragile shore road. Likewise, a surprising amount of traffic comes south along the shore road. The vehicles using this shore road include private cars and pickup trucks, commercial pickup trucks, service vans, oil delivery trucks, lumber trucks and others. In many places the vehicles travel only a few inches from the pond. All of these vehicles contribute to the deterioration of the shoreline and to the contamination of the pond.

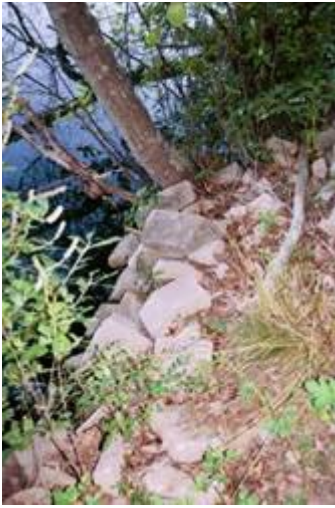
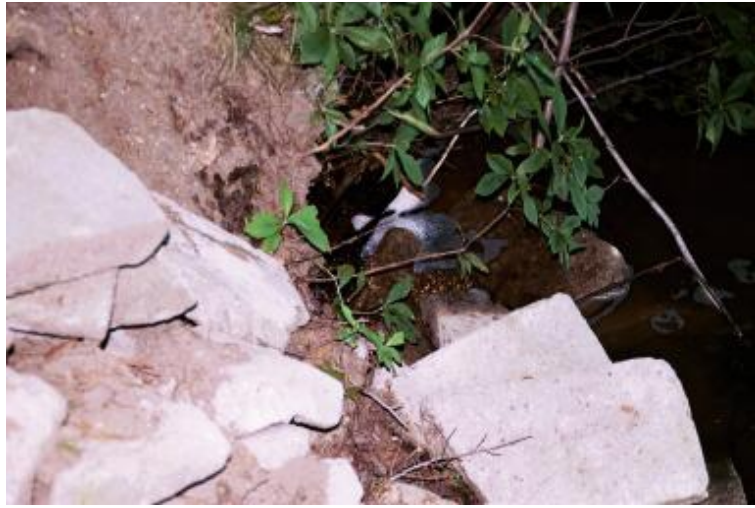
1. A narrow dirt road runs along several thousand feet of the southern and southeastern shore of Halfway Pond. This one-lane dirt road, which lies just a few feet from the shore, is used by a cranberry grower to bring in equipment to service and harvest its bogs.
2. Over the years, the cranberry grower has repeatedly cut the shore-front vegetation to the point where the buffer is just a foot or two wide in many places and has been completely eliminated in others.
3. A number of years ago, to reinforce the shoreline, the cranberry grower dumped many thousands of pieces of broken cement along a couple thousand feet of the shore. Some vegetation has grown up through the pieces which are above the water line, but the appearance of this shoreline is a truly ugly. At the very least, the Conservation Commission should review what has been done to the shore.
