Interpretation of Runoff Problems

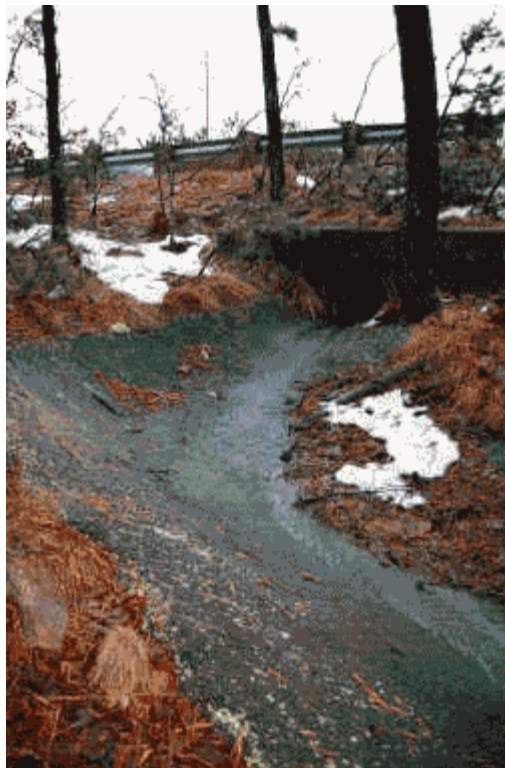
1. Bloody Pond bottle samples exhibited the highest concentrations of salts, salt components and possible highway runoff indicators. The pond was highest on Specific Conductance, Sodium, and Chloride, and second highest on Calcium, Magnesium and Hardness.

The pond has a moderate number of houses on its western side, and the slope to the pond is fairly steep

on the west, north and east. The northeastern end and eastern side of the pond is close to the southbound lanes of Route 3 (see [Catch Basins along Route 3](#)). Highway runoff flows from both directions to a relatively low area in Route 3 near the northern end of Bloody Pond. Drainage from the highway grates comes out of pipes on the steep slope down from the highway, is channeled down the slope to a small abandoned cranberry bog northeast of Bloody Pond, flows through the ditches of the bog toward Bloody Pond, and then flows through an abandoned bog flume into Bloody Pond. The Baird Center is on the northern end of the pond, and the roads in this area are paved and used on a year-round basis. On the northwestern side of the pond, there is Timberline Lane which is paved road running down a steep hill through a small subdivision. Runoff which comes down Timberline flows into drains which then pipe the runoff into a low wetland area on the west side of the road but not very far from the pond. Although Long Pond Road runs along the west side of the pond at the crest of the pond's watershed, this paved road is some distance from the pond.

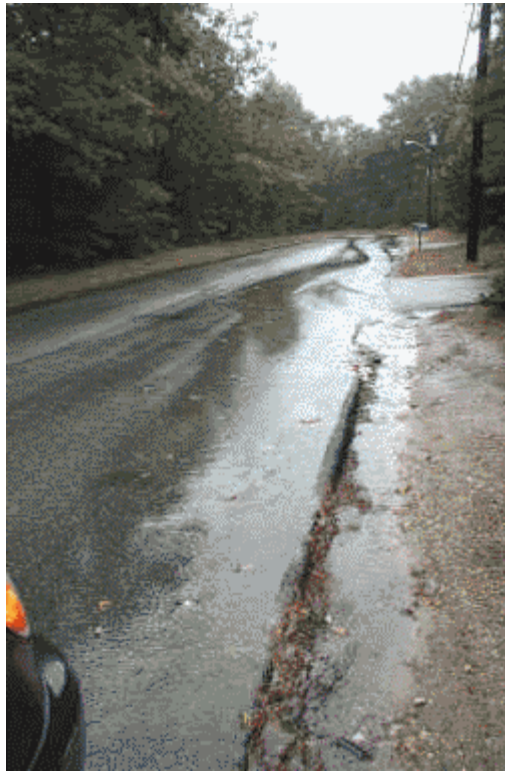
3. Long Pond ranked third in concentrations of possible runoff indicators. It had the third highest values on all seven of these parameters (Specific Conductance, Sodium, Chloride, Calcium, Magnesium, Hardness and Alkalinity).

There are only a moderate number of houses on the pond given its large size, and the sides are fairly steep. The roads and driveways on the

south and west sides of the pond are unpaved. At the northern end of Long Pond, a channel from Little Long Pond feeds nearly 3,000 gallons of water a minute into Long Pond, runoff from the paved parking lot for the State boat ramp on Long Pond flows into this channel, runoff which flows into storm drains in Plymouth Estates or flows down the road from Long Pond Road, Clark Road, Oar and Line Road and Thatcher Road (all paved roads) all ends up in this channel or runs down the State boat ramp into Long Pond.
